# Walkthrough - Oakwood Meadow Plot

Morris Construction

ADDRESS  
14 Oakwood Meadow

INSPECTED  
13 Jul 2026

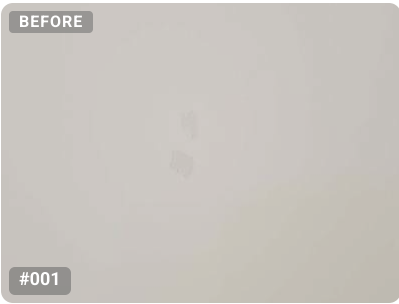
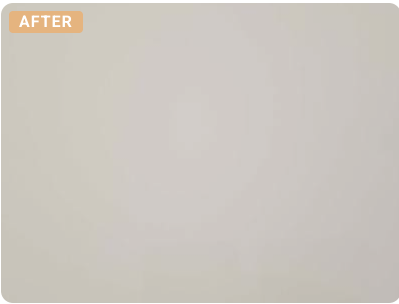
MINOR PAINT

Impact damage on plaster wall next to cabinets, resulting in chipped paint and exposed undercoat. Requires fine-surface filling, sanding, and spot-painting to match the existing wall finish.

| # | ROOM | CATEGORY | DESCRIPTION | SEVERITY | ASSIGNED | STATUS |
|---|---|---|---|---|---|---|
| #001 | Kitchen / living room | Paint | Impact damage on plaster wall next to cabinets, resulting in chipped paint and exposed undercoat. Requires fine surface filling, sanding, and spot painting to match the existing wall finish. | Minor | John | RESOLVED |

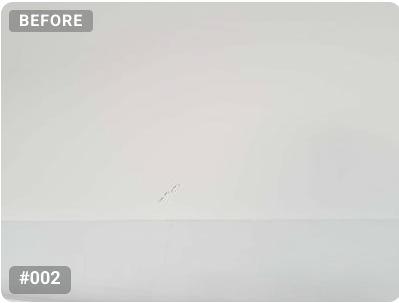
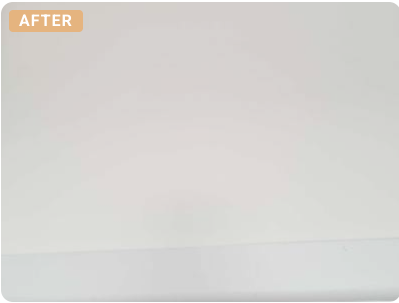
MINOR FINISH

Hairline cracking and separation in plaster wall directly above the door architrave/trim. Likely caused by timber shrinkage. Requires filling, sanding, and localized touch-up paint.

| # | ROOM | CATEGORY | DESCRIPTION | SEVERITY | ASSIGNED | STATUS |
|---|---|---|---|---|---|---|
| #002 | Kitchen / living room | Finish | Hairline cracking and separation in plaster wall directly above the door architrave/trim. Likely caused by timber shrinkage. Requires filling, sanding, and localized touch-up paint. | Minor | John | RESOLVED |

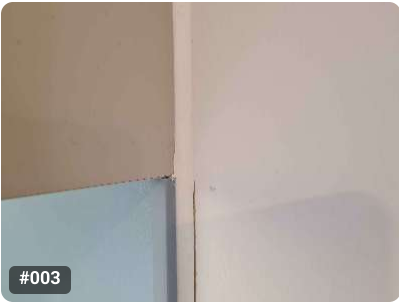
MODERATE FINISH

Vertical shrinkage gap and split caulk line at the junction where the partition wall meets the timber architrave. Existing sealant has failed. Requires stripping back, re-caulking, and repainting.

| # | ROOM | CATEGORY | DESCRIPTION | SEVERITY | ASSIGNED | STATUS |
|---|---|---|---|---|---|---|
| #003 | Kitchen / living room | Finish | Vertical shrinkage gap and split caulk line at the junction where the partition wall meets the timber architrave. Existing sealant has failed. Requires stripping back, re-caulking, and repainting. | Moderate | John | OPEN |

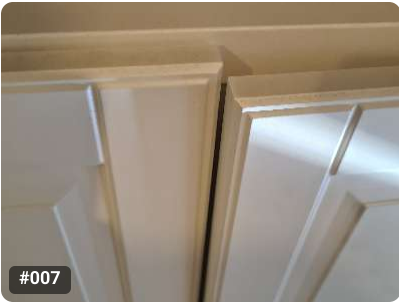
MODERATE FIXTURES

Kitchen cabinet cabinet doors are visibly misaligned with an uneven vertical gap and uneven horizontal height at the top. Cupboard hinges require manual adjustment to level the doors.

| # | ROOM | CATEGORY | DESCRIPTION | SEVERITY | ASSIGNED | STATUS |
|---|---|---|---|---|---|---|
| #007 | Kitchen / living room | Fixtures | Kitchen cabinet doors are visibly misaligned with an uneven vertical gap and uneven horizontal height at the top. Cupboard hinges require manual adjustment to level the doors. | Moderate | Rob Brown | OPEN |

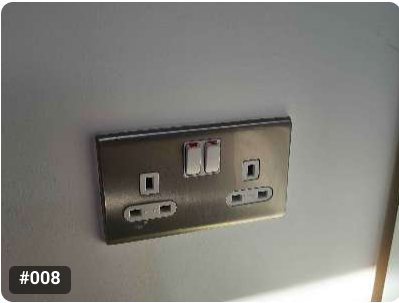
MINOR ELECTRICAL

Double electrical socket has no power. Check internal connections.

| # | ROOM | CATEGORY | DESCRIPTION | SEVERITY | ASSIGNED | STATUS |
|---|---|---|---|---|---|---|
| #008 | Kitchen / living room | Electrical | Double electrical socket has no power. Check internal connections. | Minor | George Newson | OPEN |

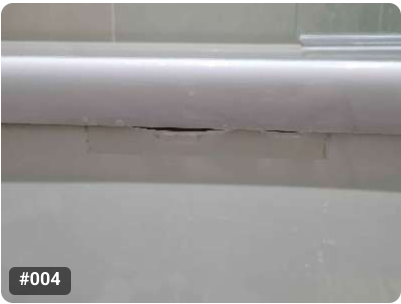
MAJOR PLUMBING

Silicone sealant has peeled away and failed along the underside lip of the bath rim panel. Significant gap present, creating an active risk of water ingress behind the bath panel. Requires removing old silicone, sanitizing, and re-applying sanitary-grade silicone.

| # | ROOM | CATEGORY | DESCRIPTION | SEVERITY | ASSIGNED | STATUS |
|---|---|---|---|---|---|---|
| #004 | Bathroom | Plumbing | Silicone sealant has peeled away and failed along the underside lip of the bath rim panel. Significant gap present, creating an active risk of water ingress behind the bath panel. Requires removing old silicone, sanitizing, and re-applying sanitary-grade silicone. | Major | Alex Jones | OPEN |

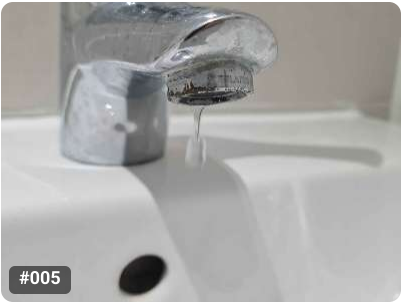
MAJOR PLUMBING

Bathroom basin mixer tap has an active, constant drip from the spout. Visible limescale and calcium buildup around the aerator nozzle. Tap cartridge requires replacement and aerator needs descaling.

| # | ROOM | CATEGORY | DESCRIPTION | SEVERITY | ASSIGNED | STATUS |
|---|---|---|---|---|---|---|
| #005 | Bathroom | Plumbing | Bathroom basin mixer tap has an active, constant drip from the spout. Visible limescale and calcium buildup around the aerator nozzle. Tap cartridge requires replacement and aerator needs descaling. | Major | Steve Clark | OPEN |

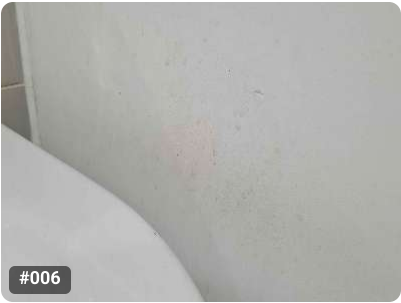
MODERATE PAINT

Localized water splashing and staining on the plaster wall adjacent to the basin/toilet. Wall lacks durable moisture-resistant paint. Requires wiping clean, applying a stain-blocking primer, and repainting with durable bathroom paint.

| # | ROOM | CATEGORY | DESCRIPTION | SEVERITY | ASSIGNED | STATUS |
|---|---|---|---|---|---|---|
| #006 | Bathroom | Paint | Localized water splashing and staining on the plaster wall adjacent to the basin/toilet. Wall lacks durable moisture-resistant paint. Requires wiping clean, applying a stain-blocking primer, and repainting with durable bathroom paint. | Moderate | John | OPEN |

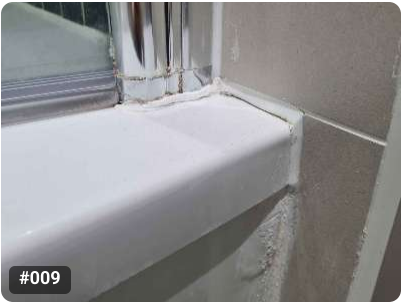
MINOR FINISH

Deteriorated, uneven, and poorly applied silicone sealant at the junction where the shower screen frame meets the tiled enclosure. Early signs of mildew growth and rust staining in the corner. Requires stripping back, sanitizing, and re-sealing with anti-mold sanitary silicone.

| # | ROOM | CATEGORY | DESCRIPTION | SEVERITY | ASSIGNED | STATUS |
|---|---|---|---|---|---|---|
| #009 | Bathroom | Finish | Deteriorated, uneven, and poorly applied silicone sealant at the junction where the shower screen frame meets the tiled enclosure. Early signs of mildew growth and rust staining in the corner. Requires stripping back, sanitizing, and re-sealing with anti-mold sanitary silicone. | Minor | Alex Jones | OPEN |

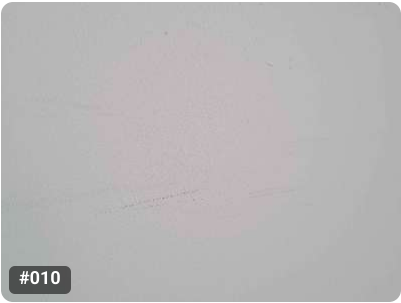
MINOR PAINT

Light horizontal scuff marks and pencil lines visible on the plaster wall. Requires light localized cleaning with an eraser; spot-priming and touch-up paint may be required if marks persist.

| # | ROOM | CATEGORY | DESCRIPTION | SEVERITY | ASSIGNED | STATUS |
|---|---|---|---|---|---|---|
| #010 | Bathroom | Paint | Light horizontal scuff marks and pencil lines visible on the plaster wall. Requires light localized cleaning with an eraser; spot-priming and touch-up paint may be required if marks persist. | Minor | John | OPEN |
